2015 Master Plan for Metcalf-Franklin Farm

I. INTRODUCTION

SUMMARY OBSERVATIONS OF EXISTING CONDITIONS

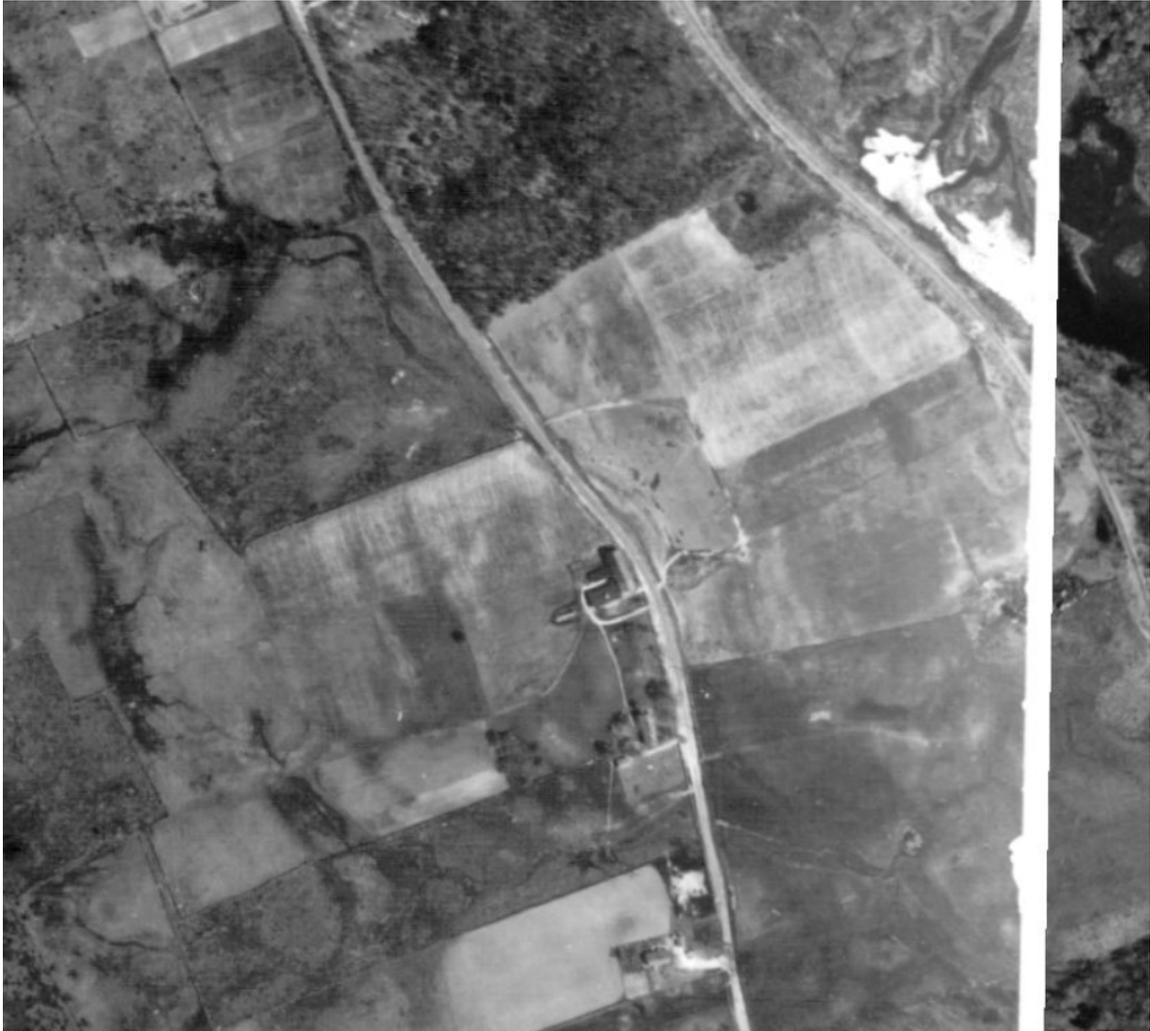
1939

Georeferenced historical aerial photography collected in May of 1939. The scanned images are panchromatic (black and white) and have a spatial resolution of approximately 4 feet.

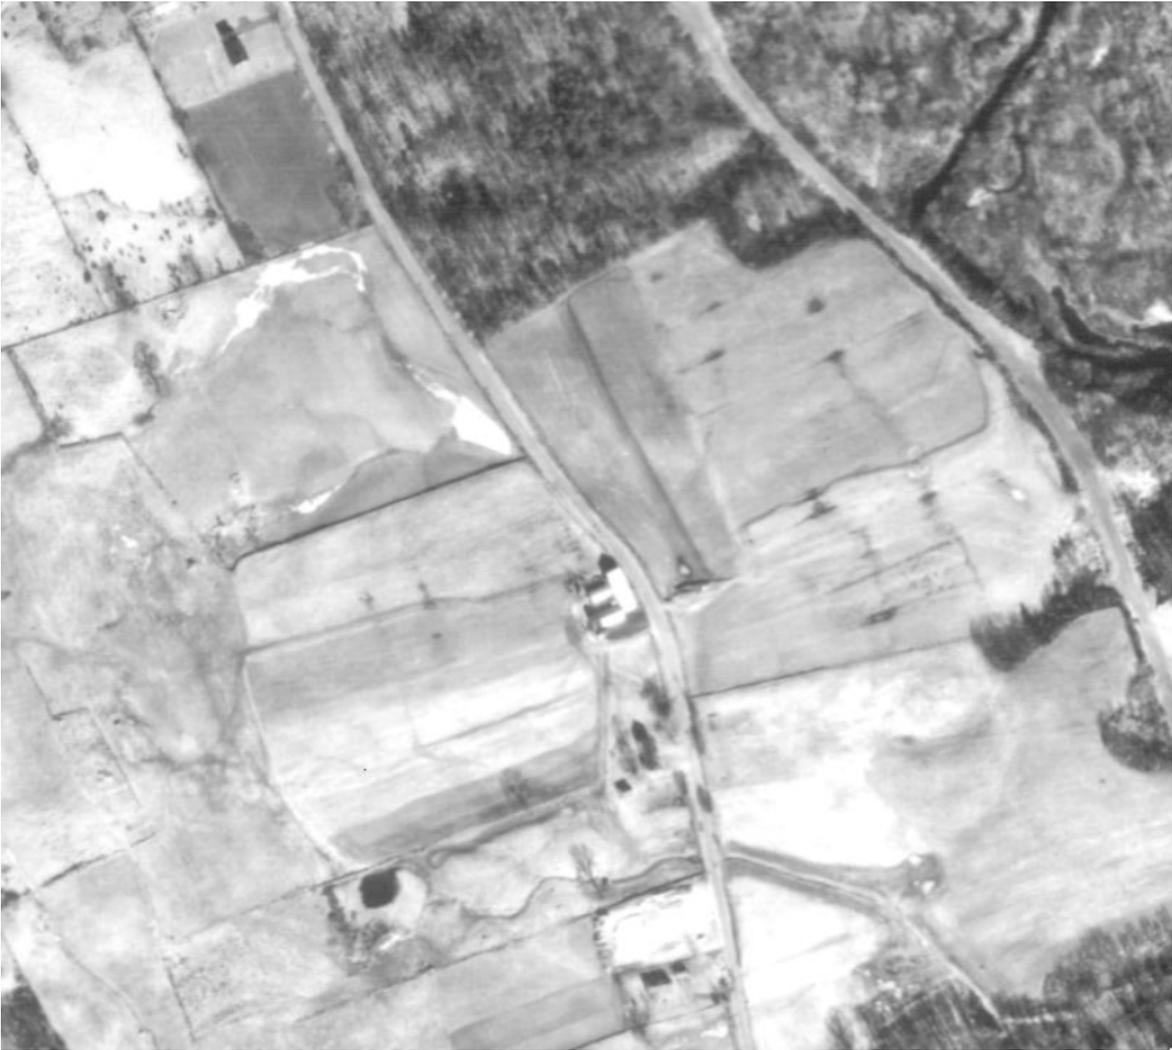
1962

Georeferenced historical aerial photography collected in the spring of 1962. The scanned images are panchromatic (black and white) and have a spatial resolution of approximately 4 feet

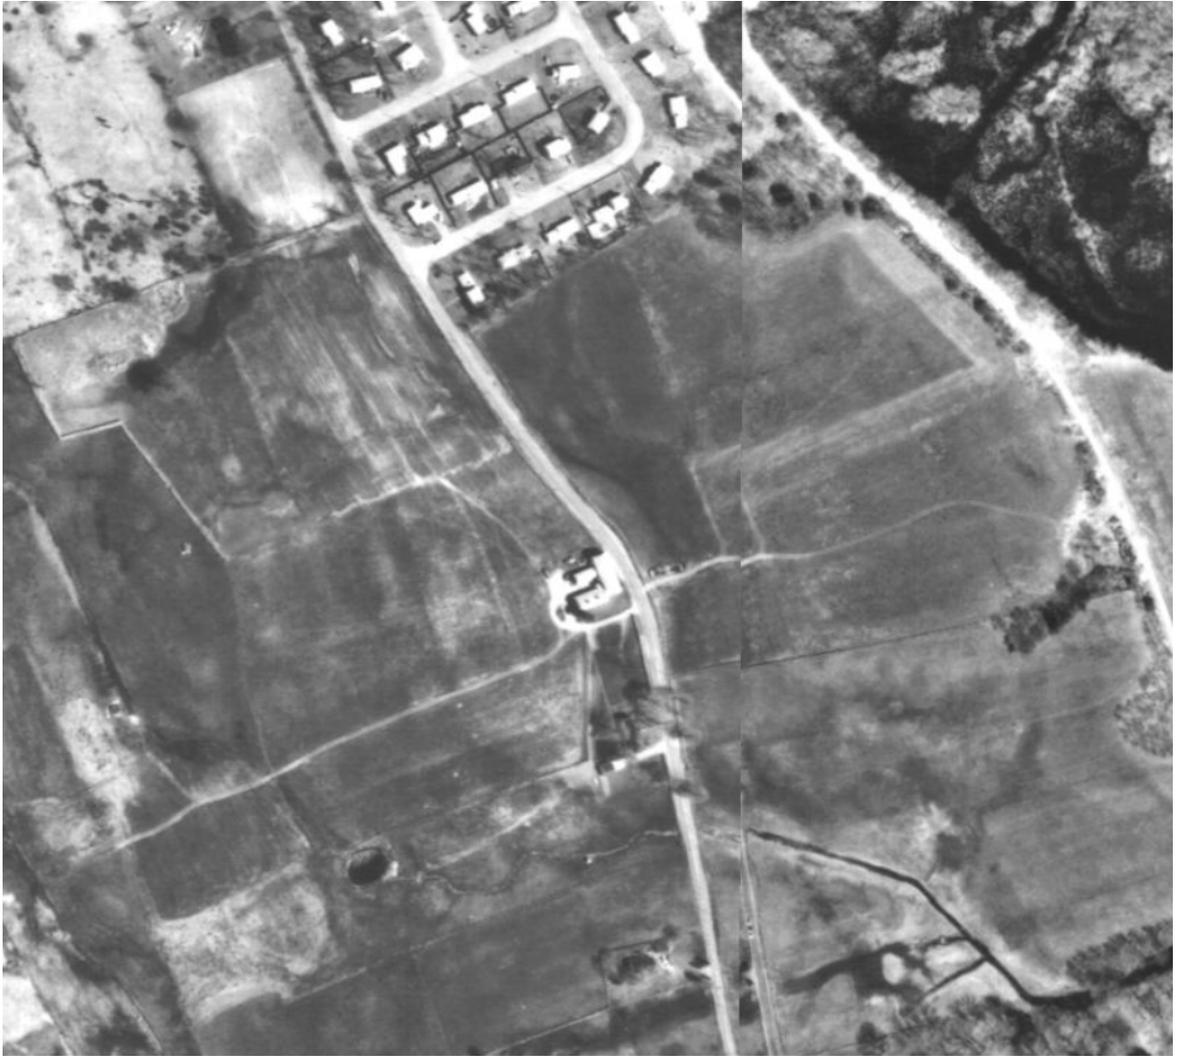
1972

Georeferenced historical aerial photography collected in April 1972. The scanned images are panchromatic (black and white) and have a spatial resolution of approximately 3.5 feet.

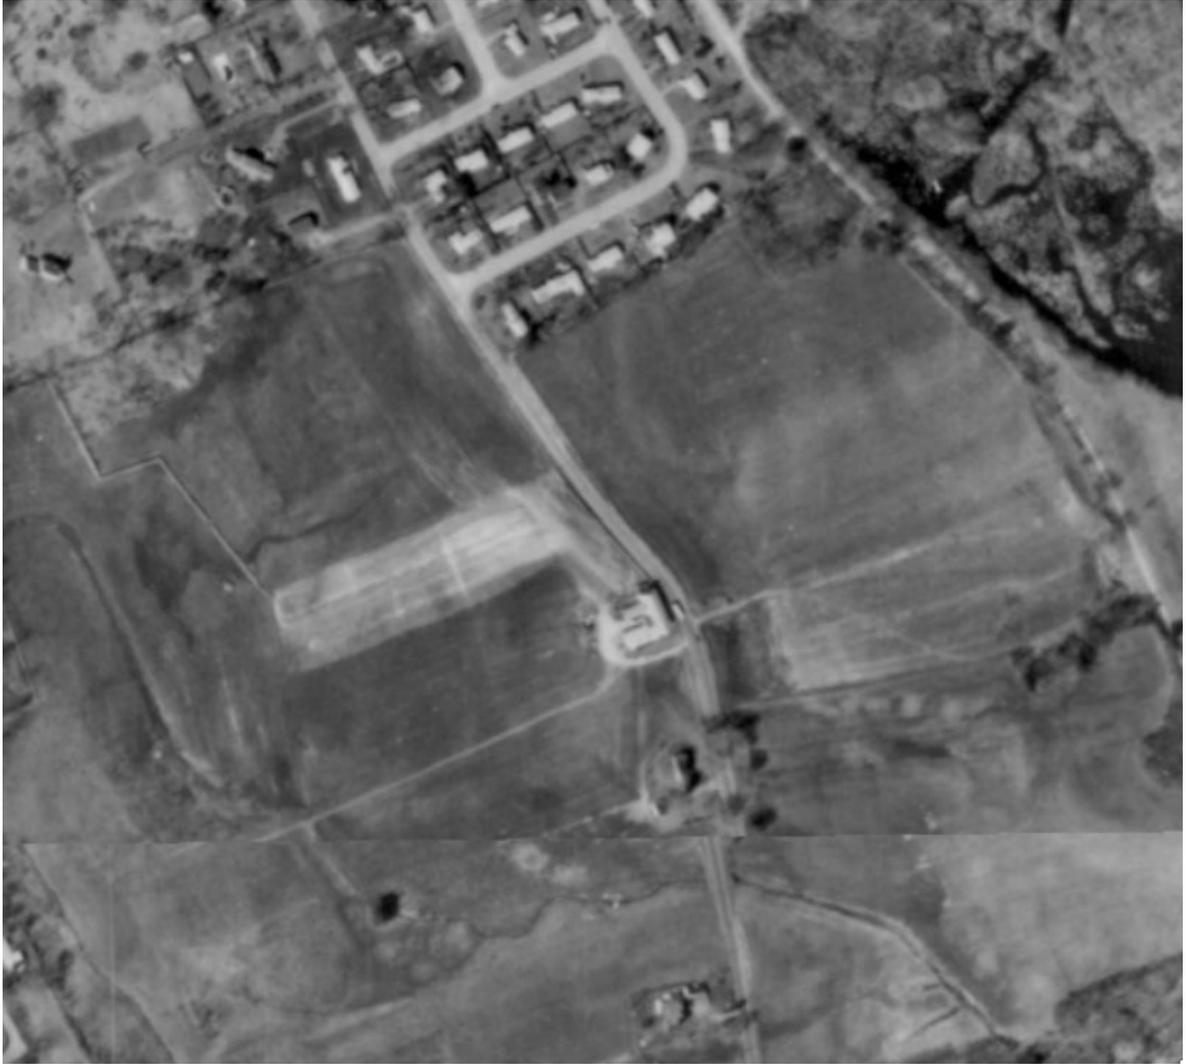
1981

Georeferenced historical aerial photography collected in April 1981. The scanned images are panchromatic (black and white) and have a spatial resolution of approximately 7 feet.

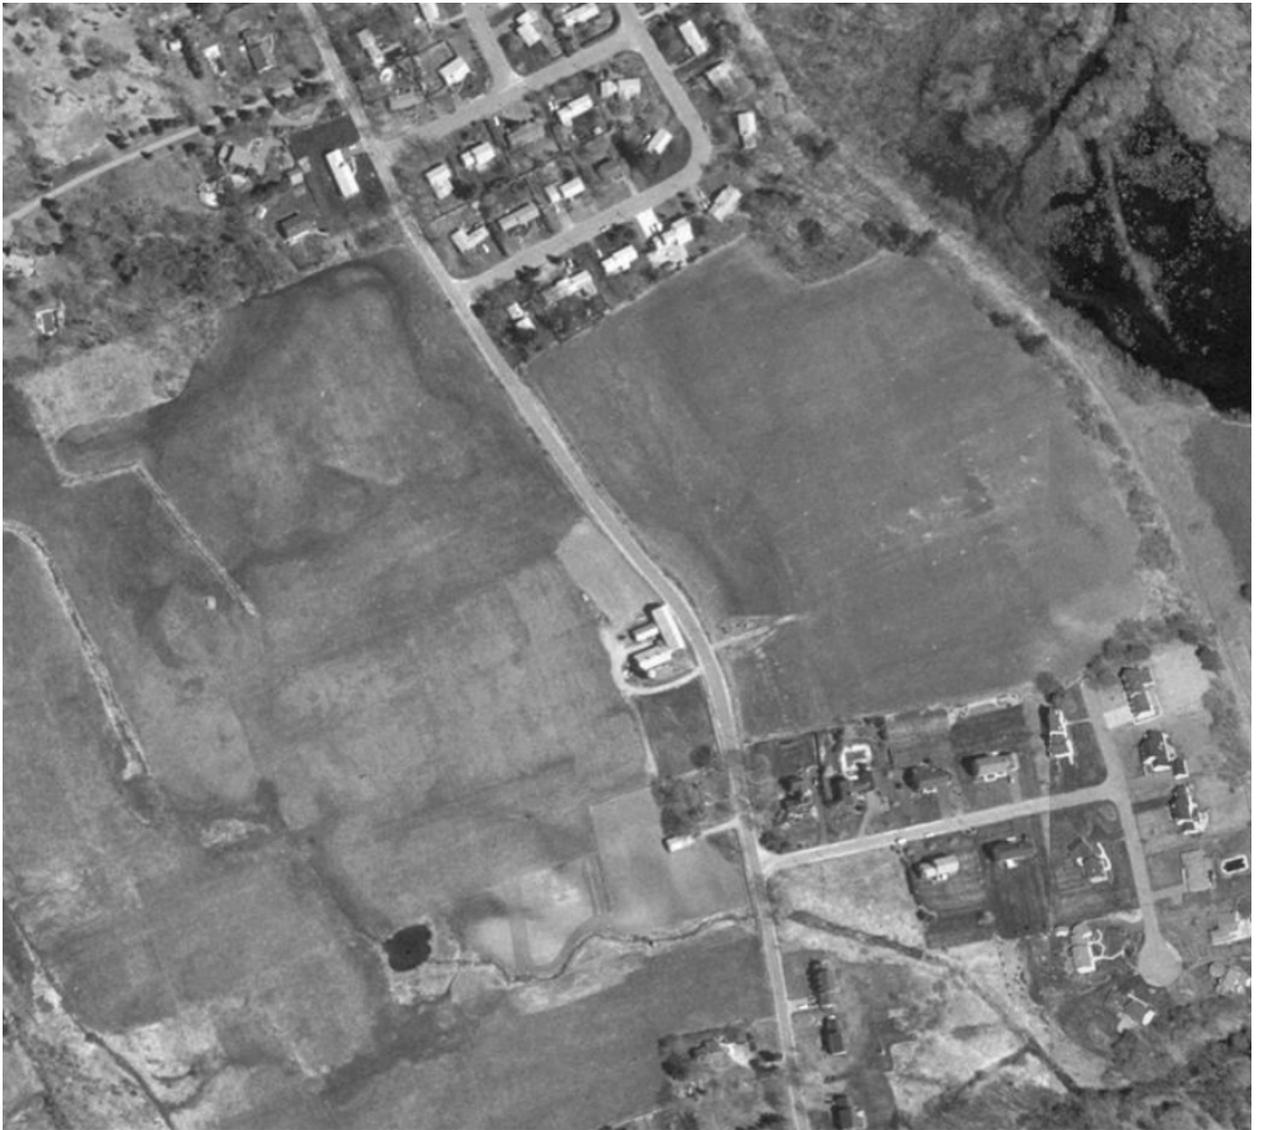
Orthophotographs collected in April of 1997 under contract by the Rhode Island Department of Transportation. The images are panchromatic (black and white) and have a 2-ft spatial resolution

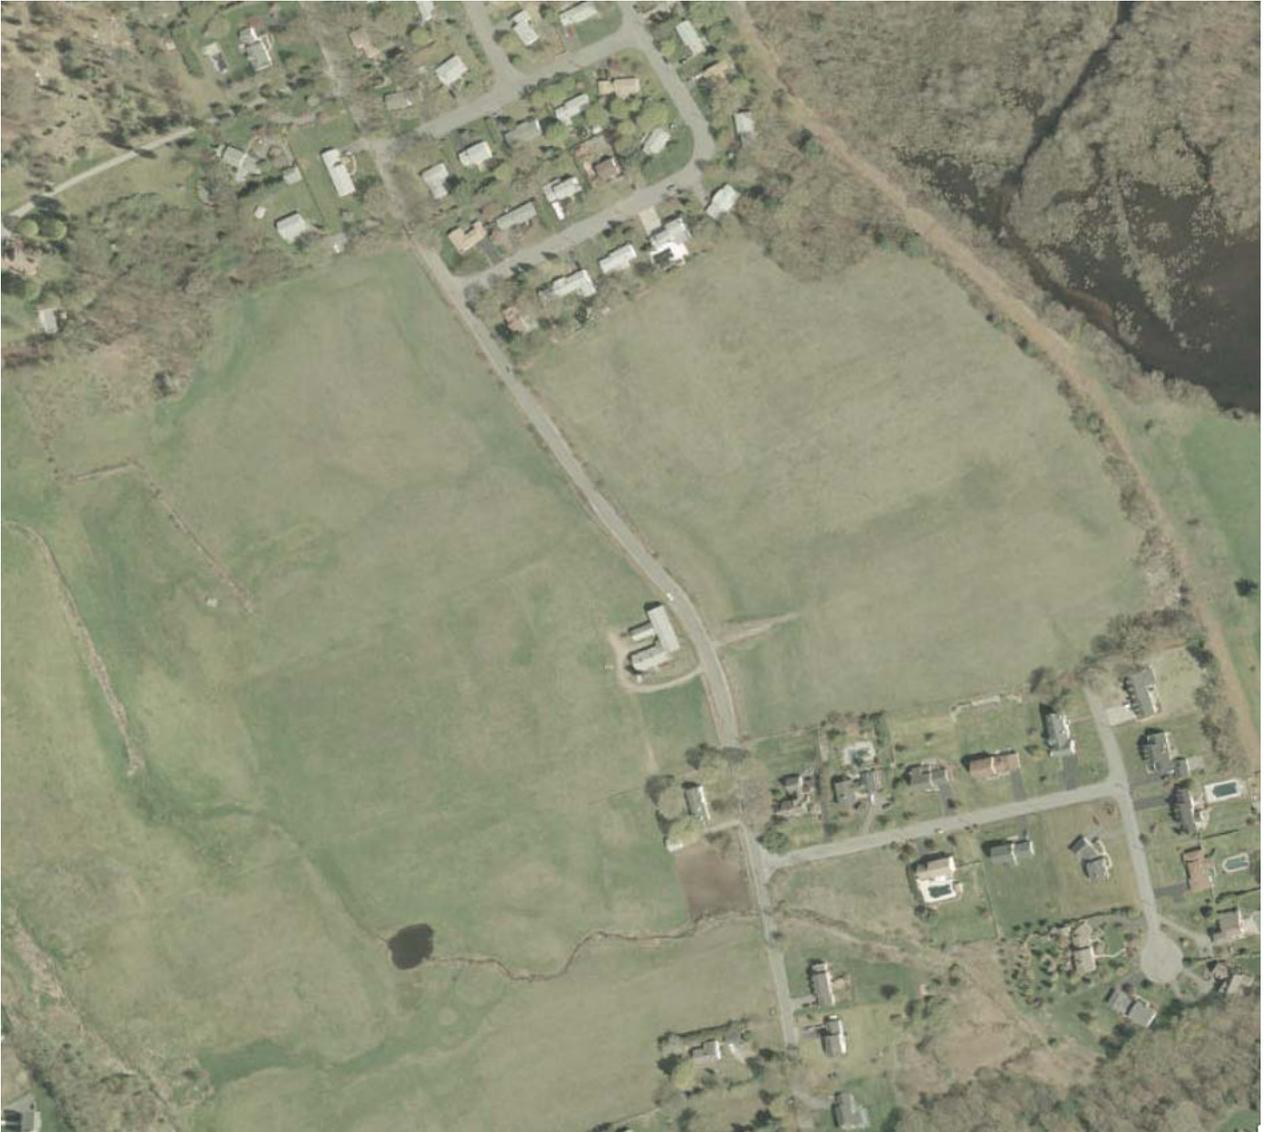
Orthophotography of Rhode Island's metropolitan core. These true color, 6-inch spatial resolution images were collected in April 2002 by the United States Geological Survey

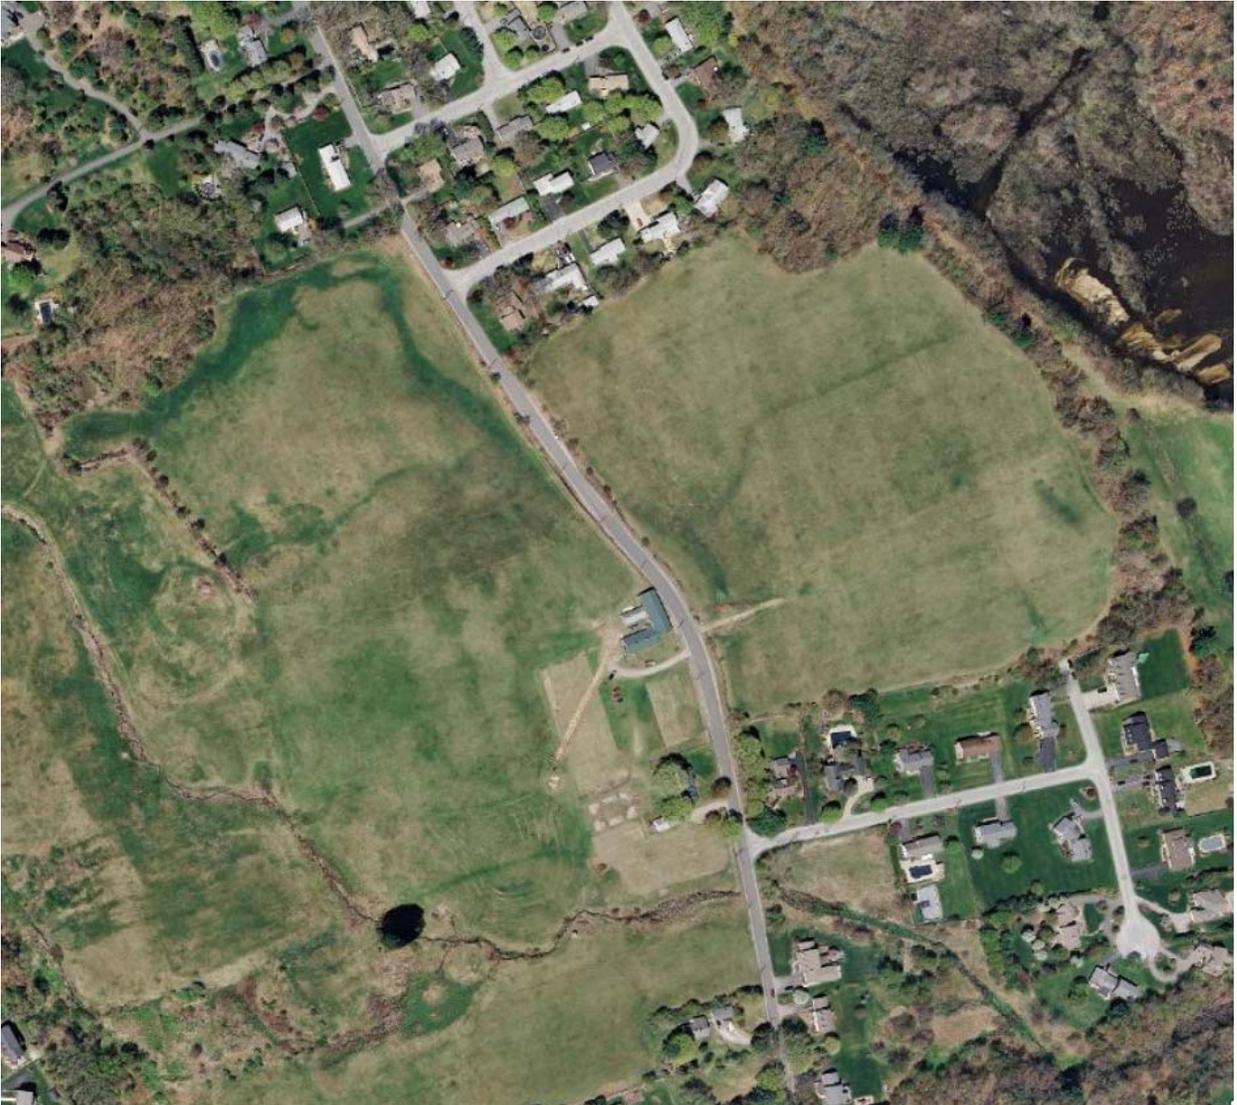
Orthorectified aerial photographs collected over April 29 - May 2, 2011 by Photo Science under contract from the Rhode Island Department of Environmental Management and USGS. The source images are 4-band multispectral (bands 1-2-3 in RGB are represented on this map), have a 6-inch spatial resolution, and are available from the Rhode Island Geographic Information System (RIGIS) consortium

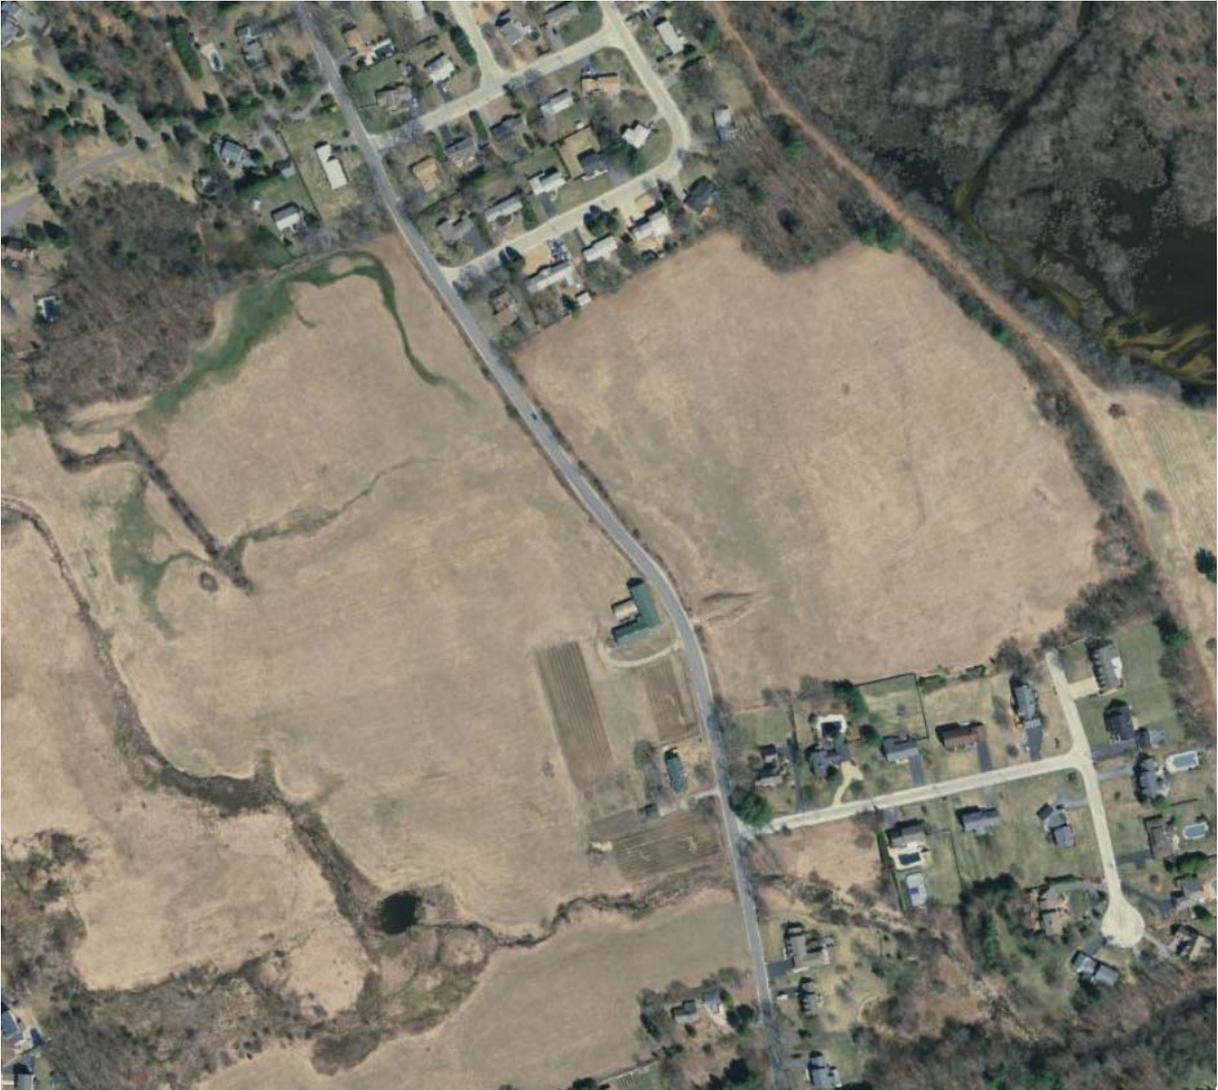
Orthorectified aerial photographs collected in April 2014 by Fugro EarthData under contract to the USGS. The source images are 4-band multispectral (bands 1-2-3 in RGB are represented on this map) and have a 1-foot spatial resolution.

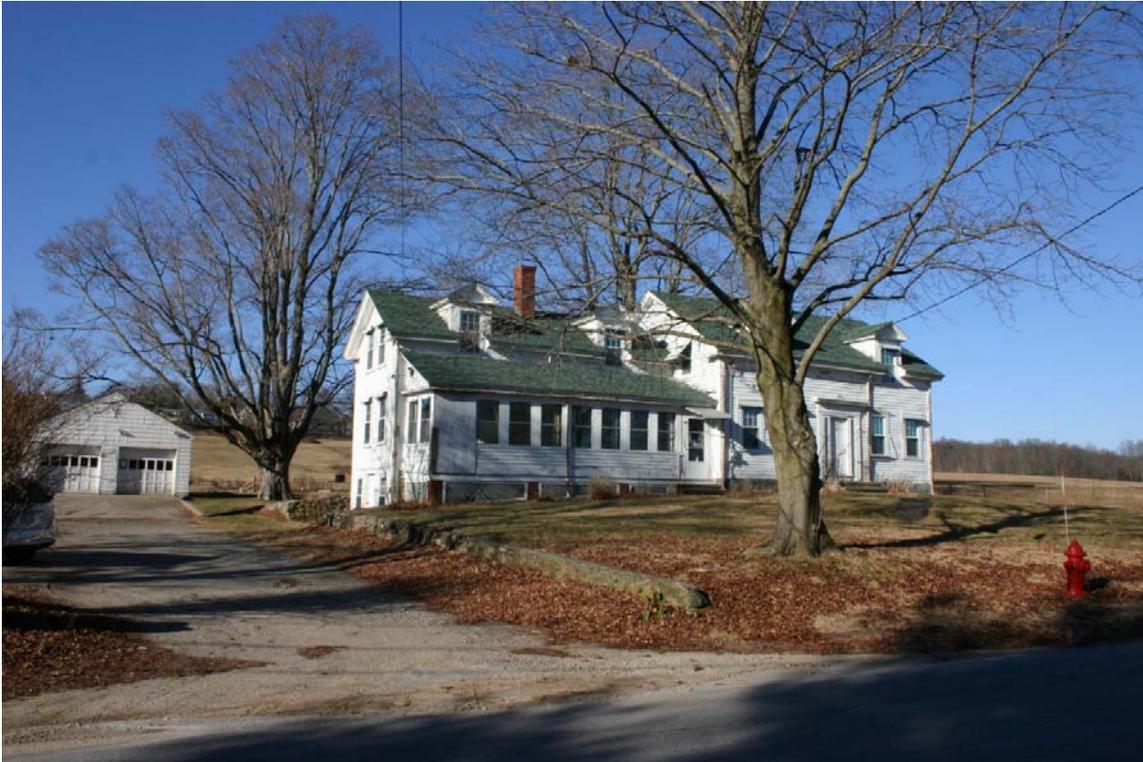
The late Greek Revival farmhouse has retained its essential form and character since its years. With some important exceptions, the house still has much of its historic fabric intact, which is quite remarkable for a structure more than 150 years old. It is a fine testament to the many generations of stewards who cared for the property. Since 2005, when the house was vacated by the Franklin family, efforts have been made by the Town and the Association to secure the house and prevent decay with the help of volunteers.

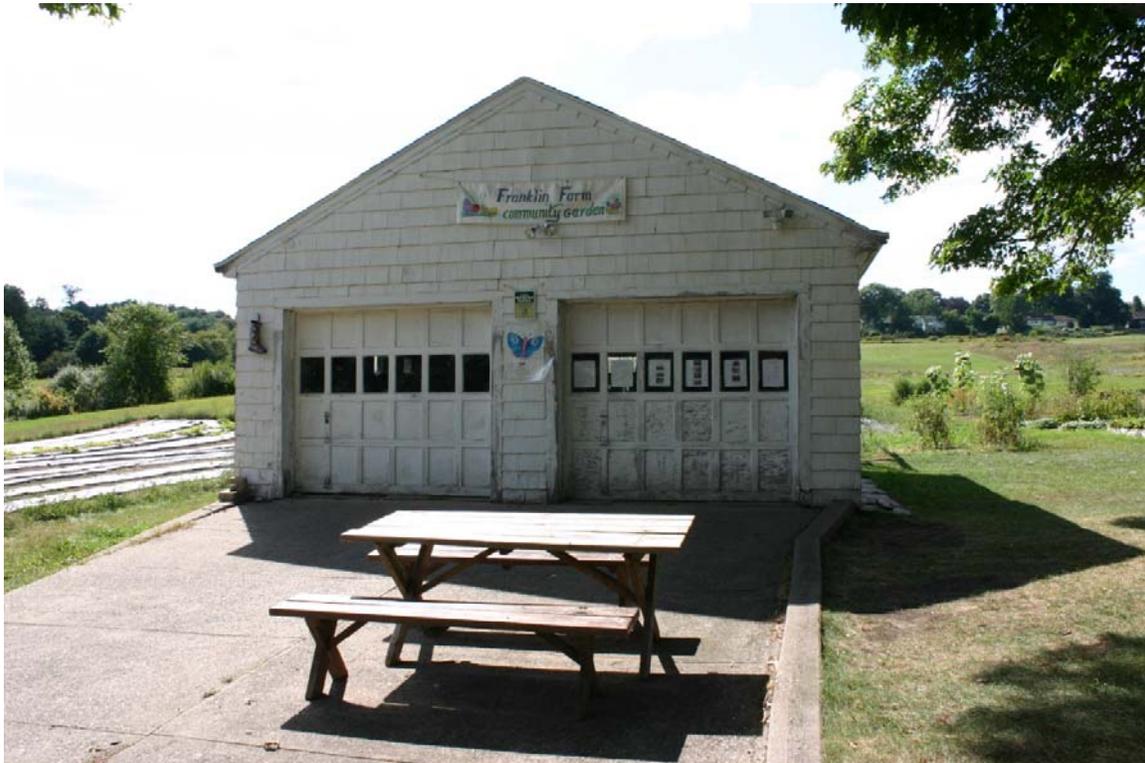
The two-car garage, fronted by a substantial concrete apron or driveway, is roughly square in plan, framed in wood, and capped by a gable roof covered with asphalt shingles. It appears to be in good condition but, like the main house, in need of minor repairs and painting. For some time, the garage has served primarily as a staging and storage space for activities related to the community farming program.

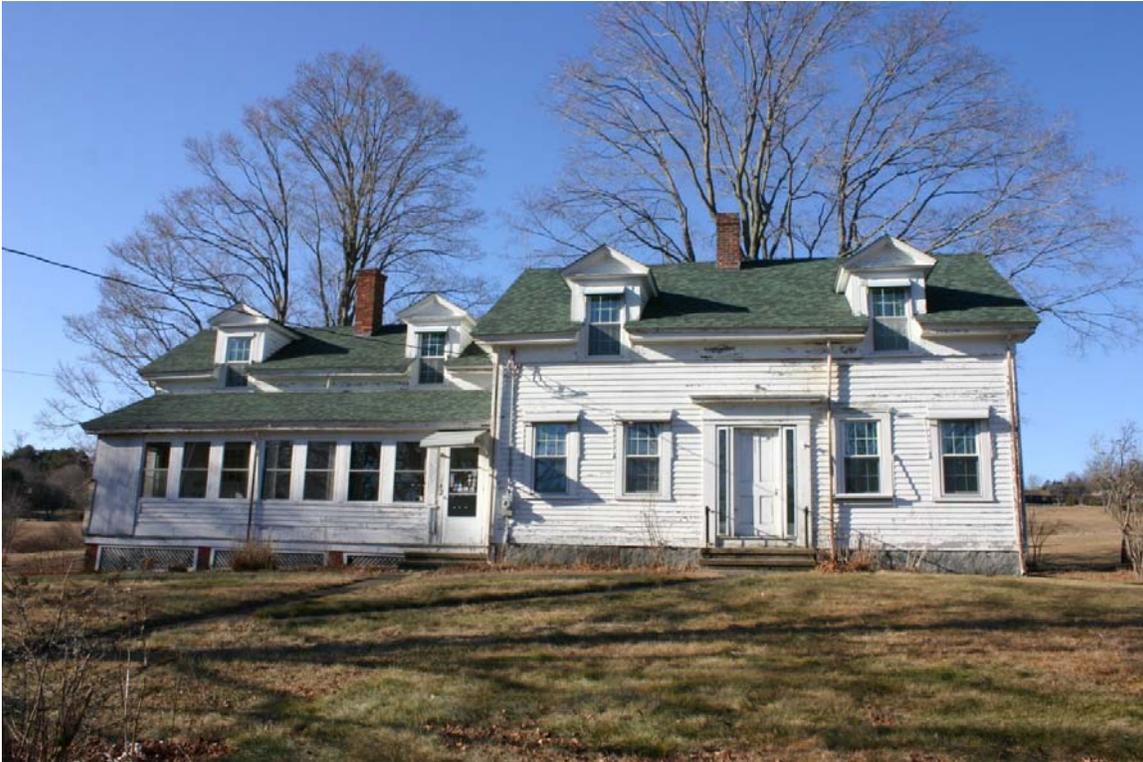
Green ‘architectural’ asphalt roof shingles, not historically appropriate, were installed a few years ago over new plywood sheathing. It also apparently covers the original built-in box gutters. Lack of gutters causes water run-off down the exterior walls on the east and west sides of the house, at times saturating the clapboards, windows, doors, and watertables below the eaves.

- *New built - in gutters to replicate originals with outlets connected to new rain leaders in existing locations.*
- *New cedar wood roof shingles to replace asphalt shingles.*
- *Repair and restoration of brick chimneys.*
- *New base, valley, edge, and counter flashings.*
- *New wood windows to resemble original windows (in place of vinyl units).*
- *Repair and restoration of broken, missing, and deteriorated components.*
- *Reconstruction of open front porch with 3 columns and railings.*
- *Repointing of masonry walls.*
- *Removal of window awnings.*
- *Stripping paint down to bare wood and repainting entire house in an appropriate historic color scheme*

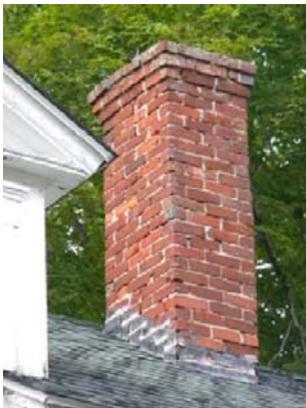
The two brick chimneys near the ridge are in need of repair and repointing.

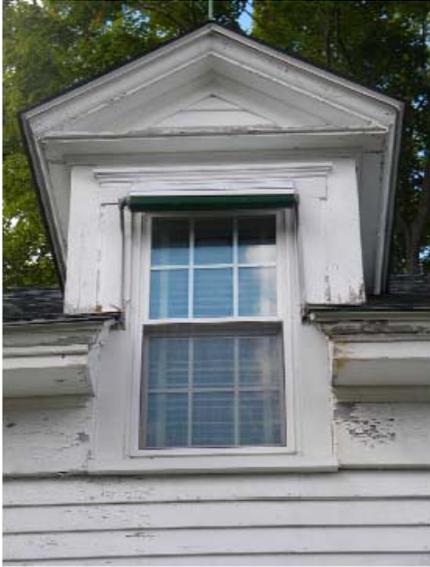
All of the windows (except the basement and porch windows) were recently replaced with vinyl windows fitted with faux muntins. It has been reported that about 17 double-hung wood sash, presumably original, are stored in

and sills have been covered by vinyl cladding, concealing and possibly causing deteriorated conditions. The front porch has thin-line double-track aluminum windows inserted into the openings (with no evidence of having had primary windows).

Many of the windows have been fitted with aluminum awnings which are in a state of disrepair and should be removed in any restoration plan.

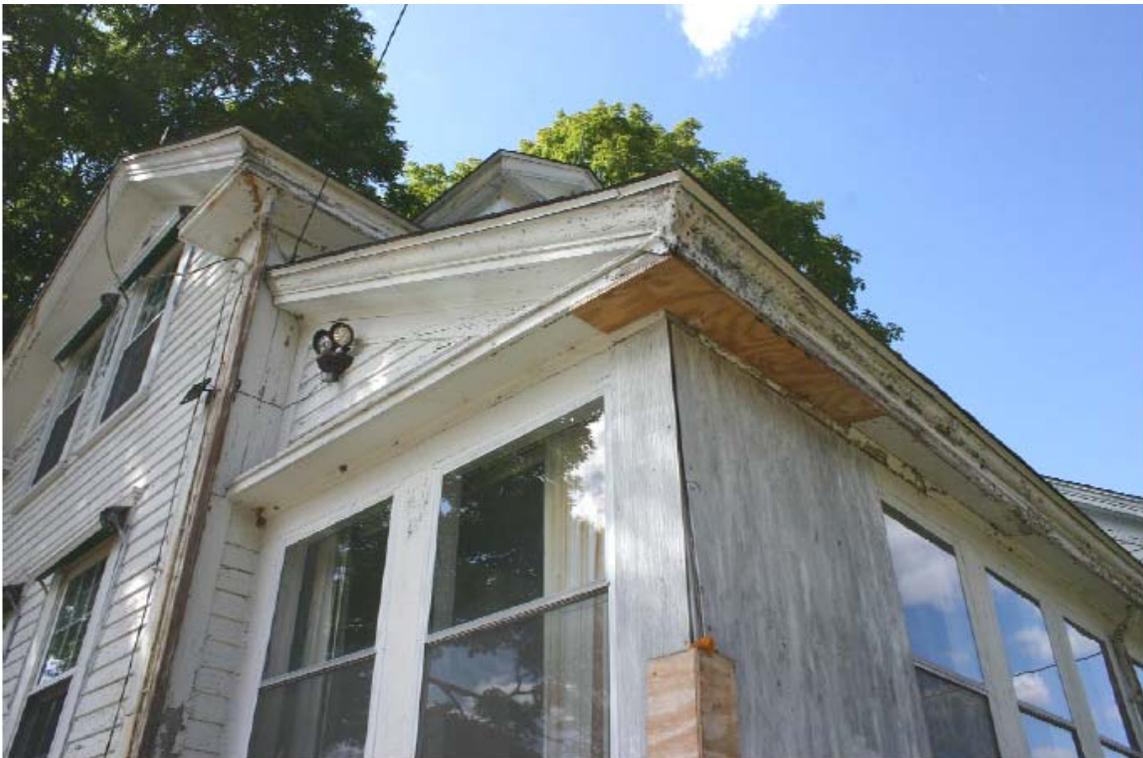
Pieces of plywood cover areas of suspected rot in soffits and at the SE corner of the porch. Foam insulation and stock trim have been used to fill gaps and holes along eaves and cornices.

Metal flashings at the base of dormers, chimneys, etc. are in suspect condition. The lead counterflashing at both chimneys is either missing or in complete disrepair.

Metal rain leaders are still mostly in place, although no longer in play since the built-in gutters were covered over some years ago.

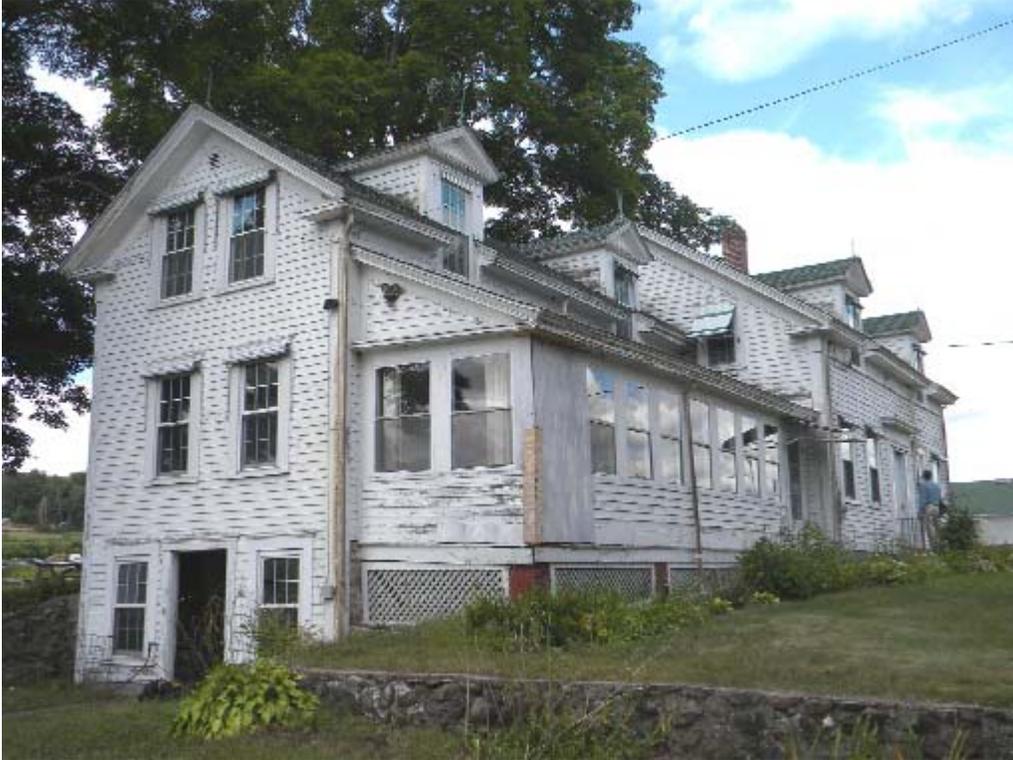
Based on physical evidence, the front porch was originally open on the east and south sides with its roof supported by 3 columns in line with the brick piers supporting the floor deck. The SE corner of the porch exhibits settlement, evidently caused by ongoing deterioration and crushing of the wood sill.

- *Consideration of localized reinforcement of the roof framing system in the event the structure is rehabilitated and requires updating to meet current snow design loads.*
- *Repair and / rebuilding of front porch floor structure as required, especially at the SE corner.*
- *New lally columns on concrete footings in basement to replace existing columns.*
- *Repairs to end of beam (next to front entry steps).*

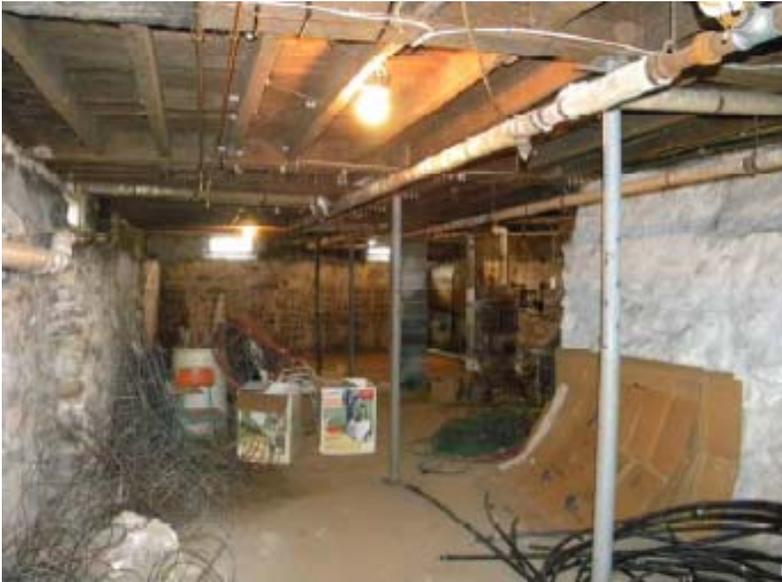
The basement of the farmhouse is unusual in that there are no load-bearing walls within the perimeter foundation. Only 4 columns and 2 masonry chimneys interrupt the openness. Internal access is provided with a wood staircase in the SW corner. A wide door at the south end of the ell affords easy access from outside and a set of steps on the west side provides access through a metal bulkhead.

The rough field stone foundation walls appear to be in a solid and stable condition. Much of the stone work has been parged and some of it whitewashed. The impressive cut granite stones on which the house sits appear to be in good condition with only some discoloration and paint on the surface.

- *Structural repairs in basement (as per Yoder's report).*
- *Masonry repairs of foundation walls.*
- *Removal of composition board in basement ell ceiling.*
- *Removal of kitchen and bathroom appointments completely.*
- *Creation of apartment on 2nd floor as shown on drawings.*
- *Creation of new rear entry, two toilet rooms, wider doorways, etc. on first floor as shown on drawings.*
- *Repair and restoration of historic finishes.*
- *New doors and hardware where needed.*

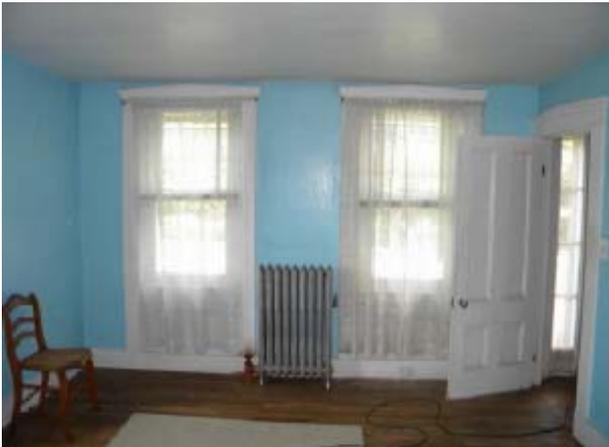
Upstairs, the domestic interior features mid-19th Century details worthy of preservation, including 4-paneled wood doors and hardware, door and window casings, a 'false' mantel piece in the NE parlor, and a staircase with turned newel posts, molded handrails, and square balusters in stained mahogany. There is some evidence of faux-marble finishes on original woodwork.

Most of the walls and ceilings, made of horse-hair plaster on wood lath, are still largely intact with some cracking due to aging, thermal stresses, and settlement.

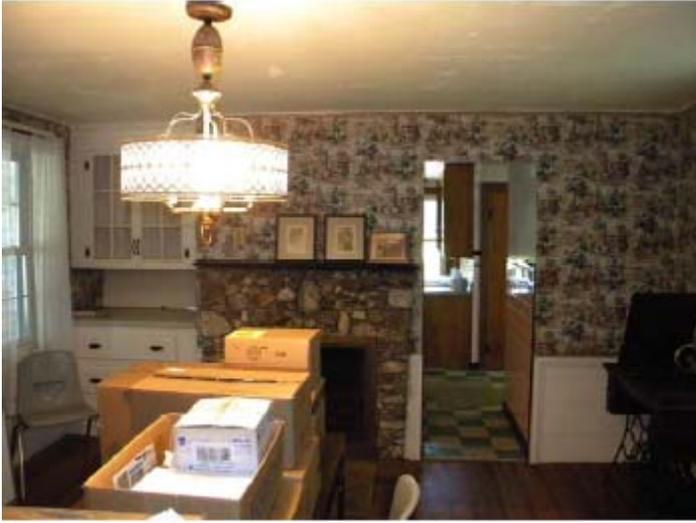
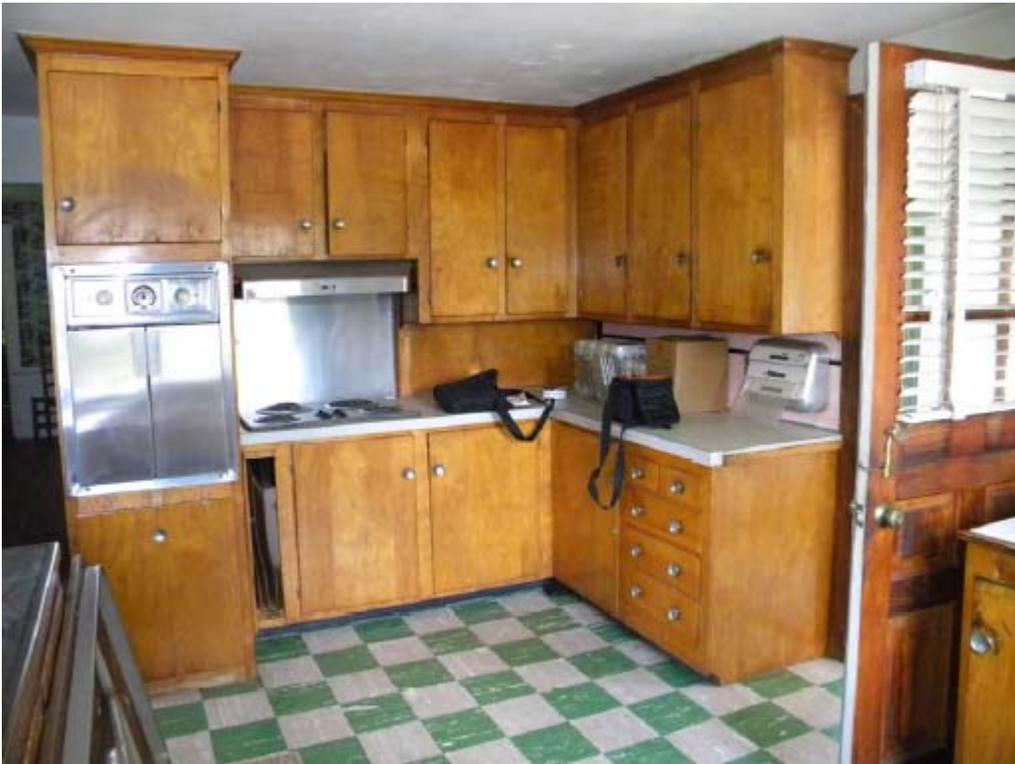
During the 20th Century, the fireplace on the 1st floor ell was rebuilt with a rustic stone mantel of pink granite and quartz pieces and a brick hearth; the kitchen was remodeled in

a vintage 1950's style with cabinets and stainless steel appliances and sink countertop; the bathrooms were also remodeled with all 1950's plumbing fixtures and finishes. Some of the walls were wallpapered and many of the floors on the first floor were apparently recovered with oak strip flooring, probably over the existing bare wood floors.

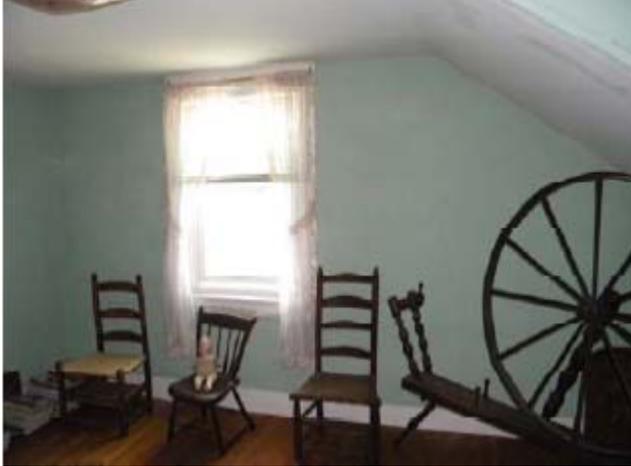
Upstairs, much of the interior rooms are still largely intact since the beginning. One room has been 'furnished' recently with antique pieces, lending it a sense of history. At the top of the central stairs, a ceiling hatch affords access to the attic. From a cursory look, the structural framing of the roof appears to be in sound condition. A layer of loose glass fiber insulation between the ceiling joists is quite thin and compact. The attic space is ventilated with louvers in the gable ends.

In several locations, holes have been made to access plumbing pipes in walls and ceilings and expel squirrels. Sections of plaster ceiling on the 2nd floor have deteriorated (and fallen) due to water infiltration over time. However, it appears that plaster damage occurred prior to the reroofing project.

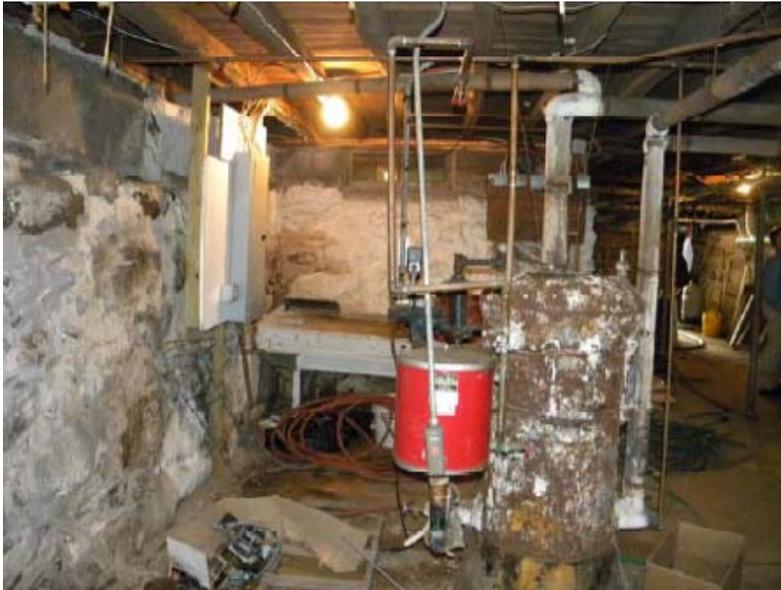
Since the 1930's, it is believed the house was heated with an oil-fired steam boiler in the basement providing heat to cast iron radiators in most rooms. The system has been disconnected and abandoned in place some years ago, leaving the house without heat through the winters.
