Cumberland Historic District Property Owner's Guide

*Cumberland Historic District Commission
Cumberland Planning Department
Youngken Associates
Landscape Elements, LLC*

Cumberland Historic District Commission

June, 2018

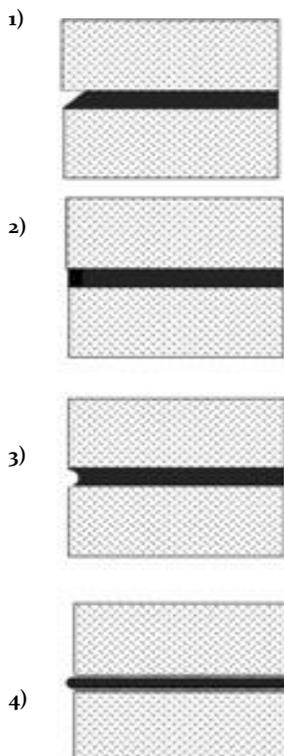
MORTAR JOINTS

- 1) Struck with drip
- 2) Flush
- 3) Tooled
- 4) Beaded (raised)

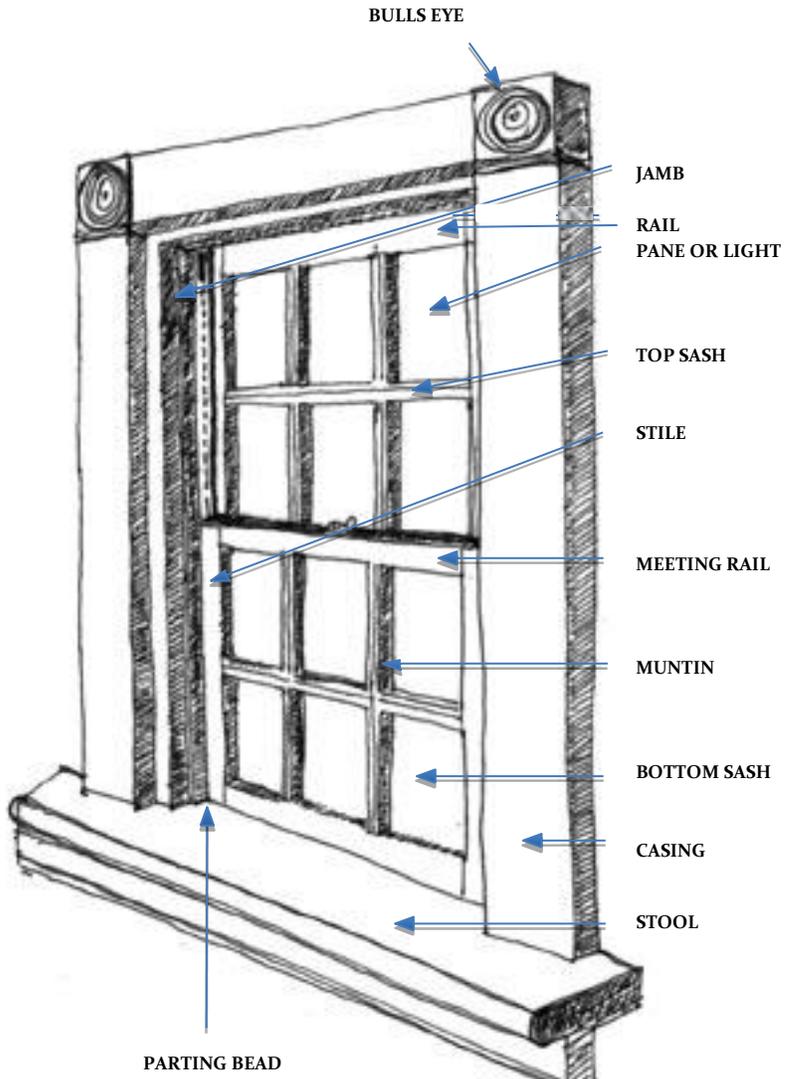
DOUBLE-HUNG WINDOW PARTS

WINDOW TERMS

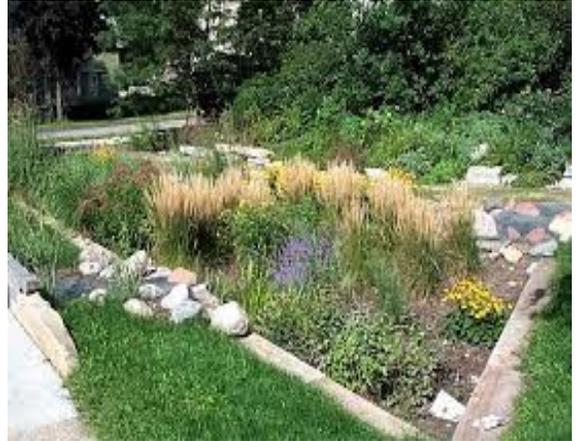
Consider rain gardens for small scale places and drip edges (below) . These can aid in storm water runoff control.

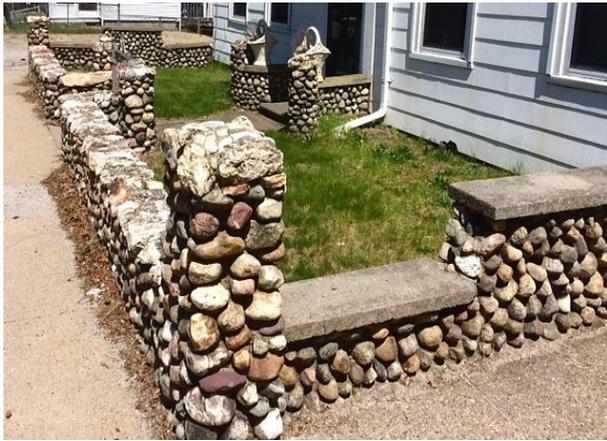
There are several types of historic fences and walls, including this cobbled or beach stone wall, dry-laid and field stone walls, and wooden picket fences. Whenever possible, these should be preserved and retained.

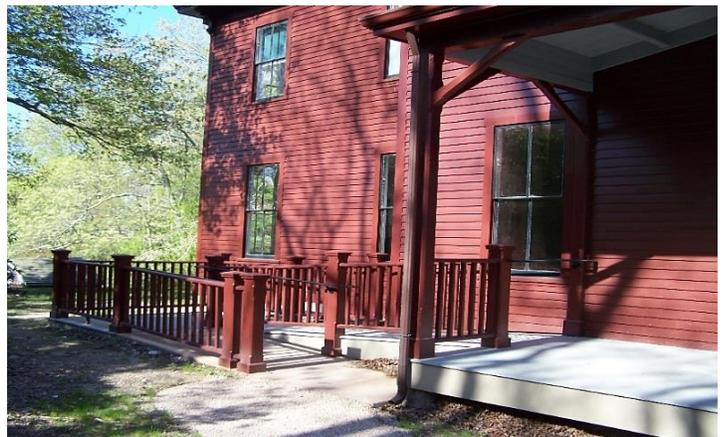
APPROPRIATE ADA RAMP: on side, railing blends with the building, regrading minimizes overall length. Often regrading to bring the ground level up to meet the door threshold level is a simple solution to providing access.
